EDF-5727

1. Title: Corrosion Evaluation for Stainless Steel V-Tanks				
2. Index Codes:				
Building/Type	TSF-09/-18	SSC ID	V-1, V-2, and V-3	Site Area TAN and ICDF

5. Summary:				
<p>The V-Tanks are scheduled to be placed in the ICDF landfill. This Engineering Design File provides a corrosion evaluation for these tanks. The stainless steel V-Tanks will experience extremely slow general corrosion from the outside soil conditions and the inside conditions. The general corrosion will only remove a very small fraction of the wall thickness. The V-tanks should remain structurally sound over 10,000 years, but there is a chance that there could be small local areas of pitting and cracking in areas of high tensile stress.</p>

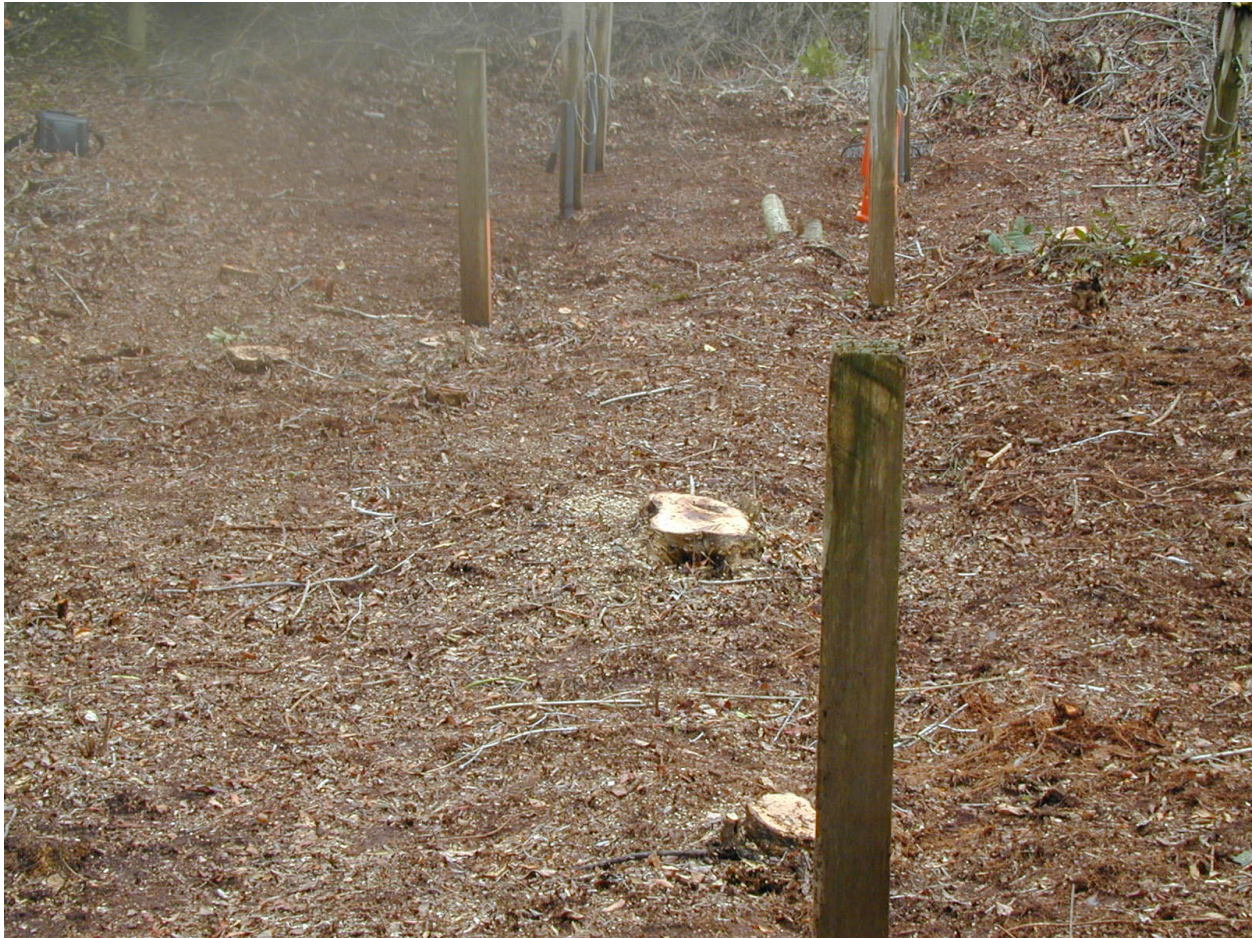
Figure 3. Buried coupon site prior to coupon removal. The coupons were buried two feet deep and there was considerable vegetation that had to be removed. Coupons were buried under the posts.

Corrosion coupons were recently excavated after having been buried for at a saturated East Coast environment. These coupons had been buried for 34 years in New Jersey. These data are still being compiled; however, the coupons give a good indication of possible localized corrosion conditions if Eastern Idaho ever experiences a wetter climate. These coupons indicate that localized corrosion is possible and pitting and cracking could occur. However, the nature of localized corrosion means that structurally the tank would be adequate for 10,000 yr, but there could be a breach in the vessel wall. The following photographs document the type of coupon environment and their condition. One coupon shown was severely sensitized (2 hr at 650 °C) before burial making the alloy more prone to cracking and pitting. The only place on the V-tanks that would have any sensitization would be in the heat-affected zone next to the weld (if the tanks are 304 and not 304L stainless steel). However, the heat-affected zone would only have been in the sensitization temperature range (about 500 to 900 °C) for a short time during welding. The other coupon was in the solution-annealed condition. This is the condition for all other areas of the V-Tanks. These results indicated that even in the solution annealed condition there is a chance for through wall cracks and pits if Eastern Idaho's climate becomes wetter or the local ground water chemistry becomes more corrosive.

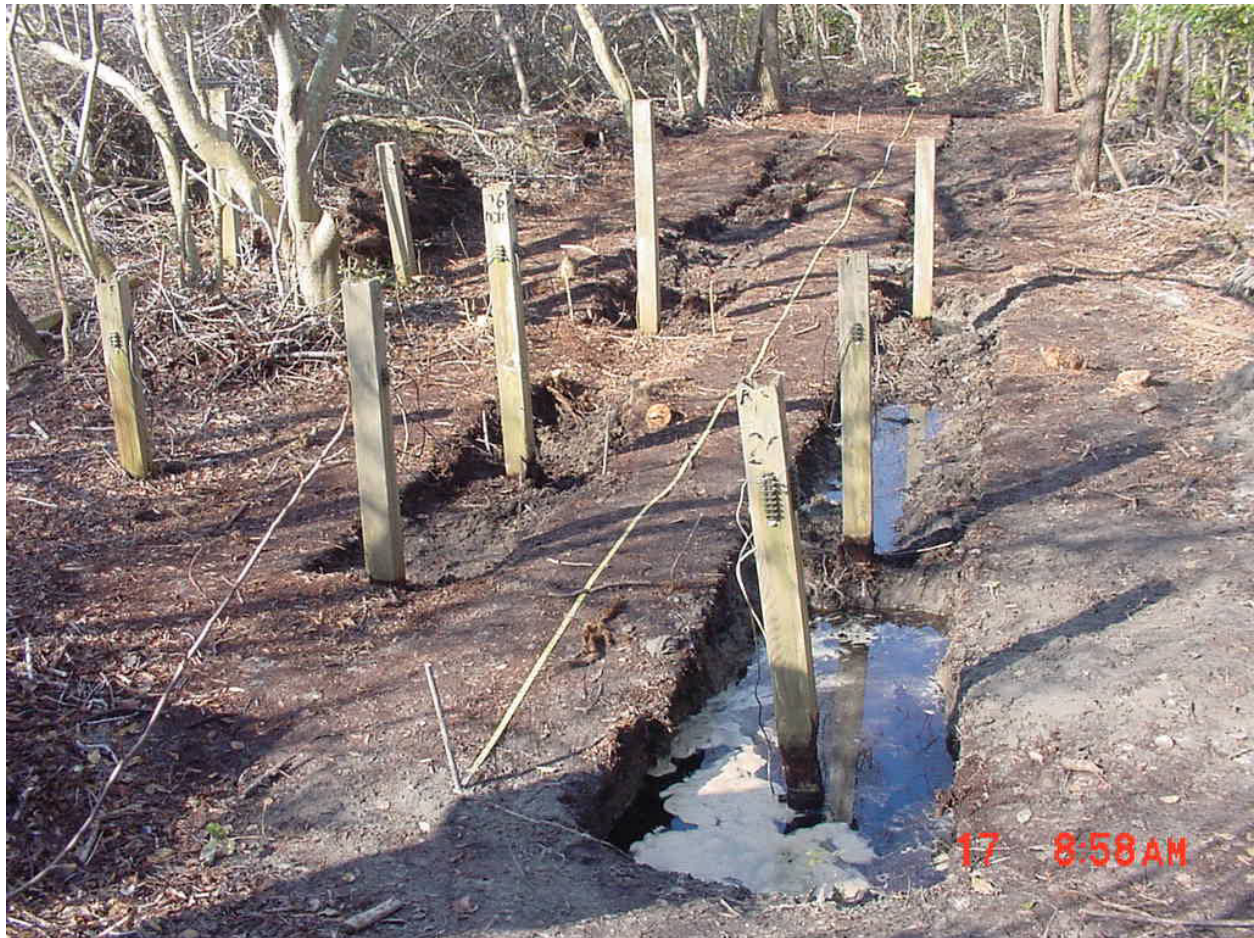
Figure 4. Coupon site after partial excavation. The water table was near the surface. As soon as digging commenced water was encountered.

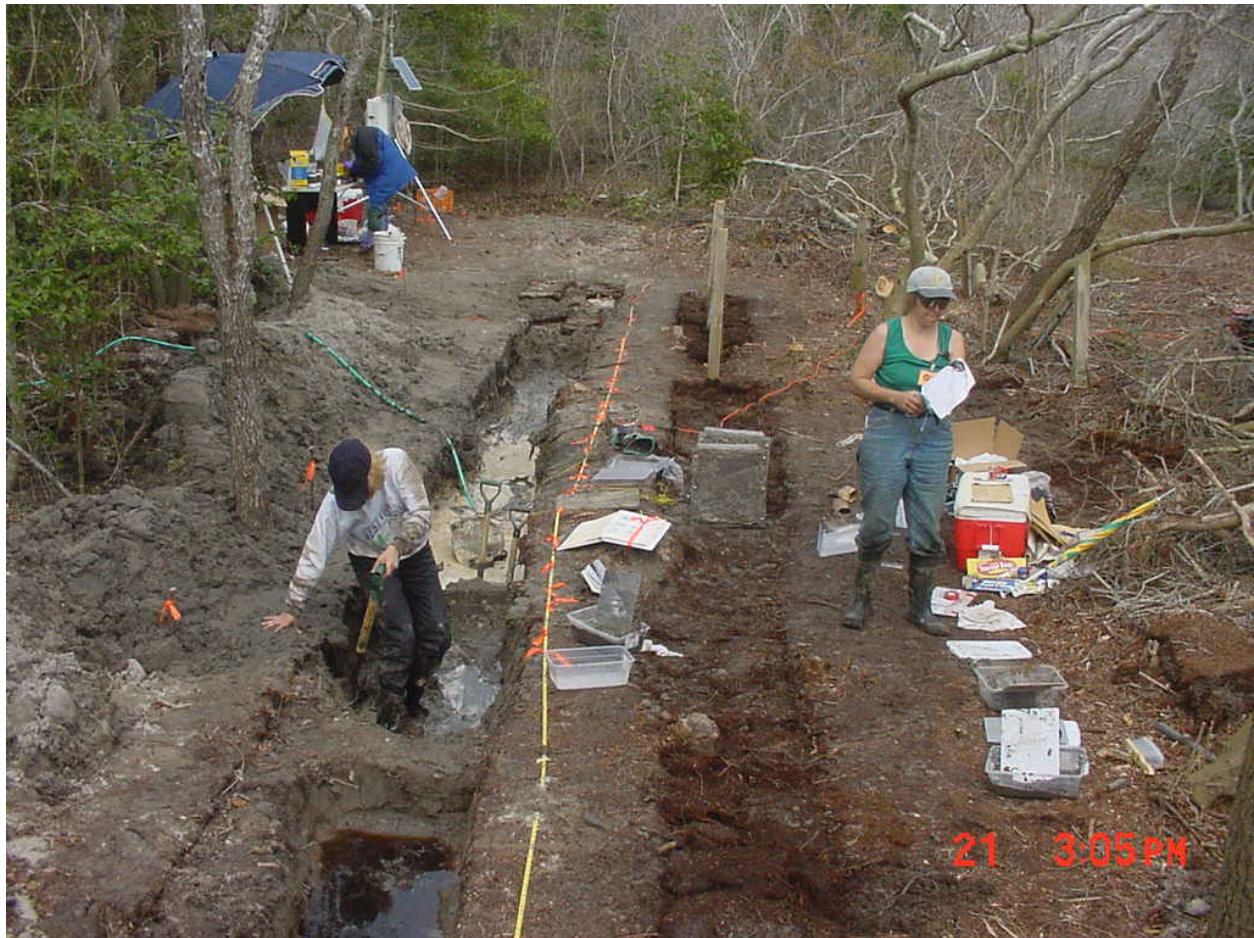
Figure 5. Coupon removal in progress

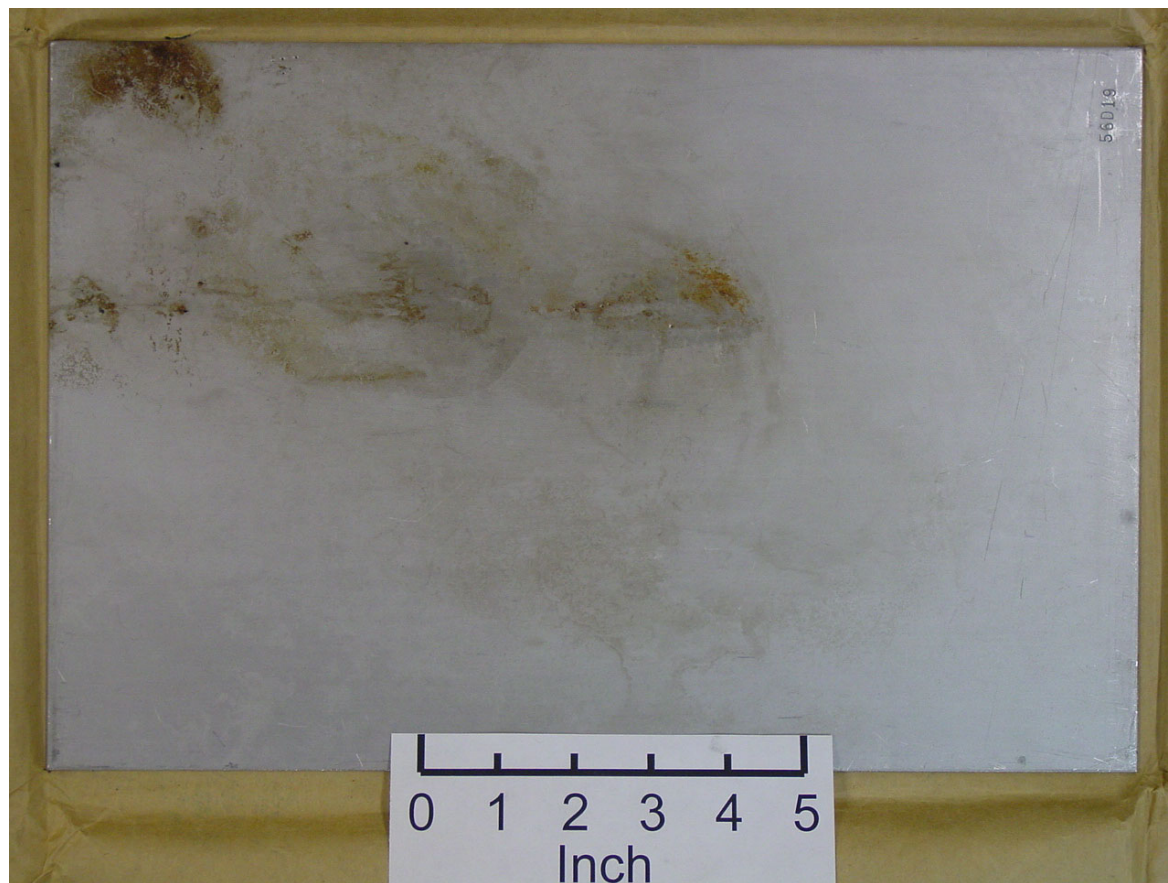
Figure 6. Type 304 stainless steel coupon after removal from wet soil after 34 years. The coupon had been sensitized for 2 hours at 650 °C. Heating the coupon to this temperature causes the microstructure to become more prone to pitting and cracking. This is an extremely severe condition not found in the V-tanks.

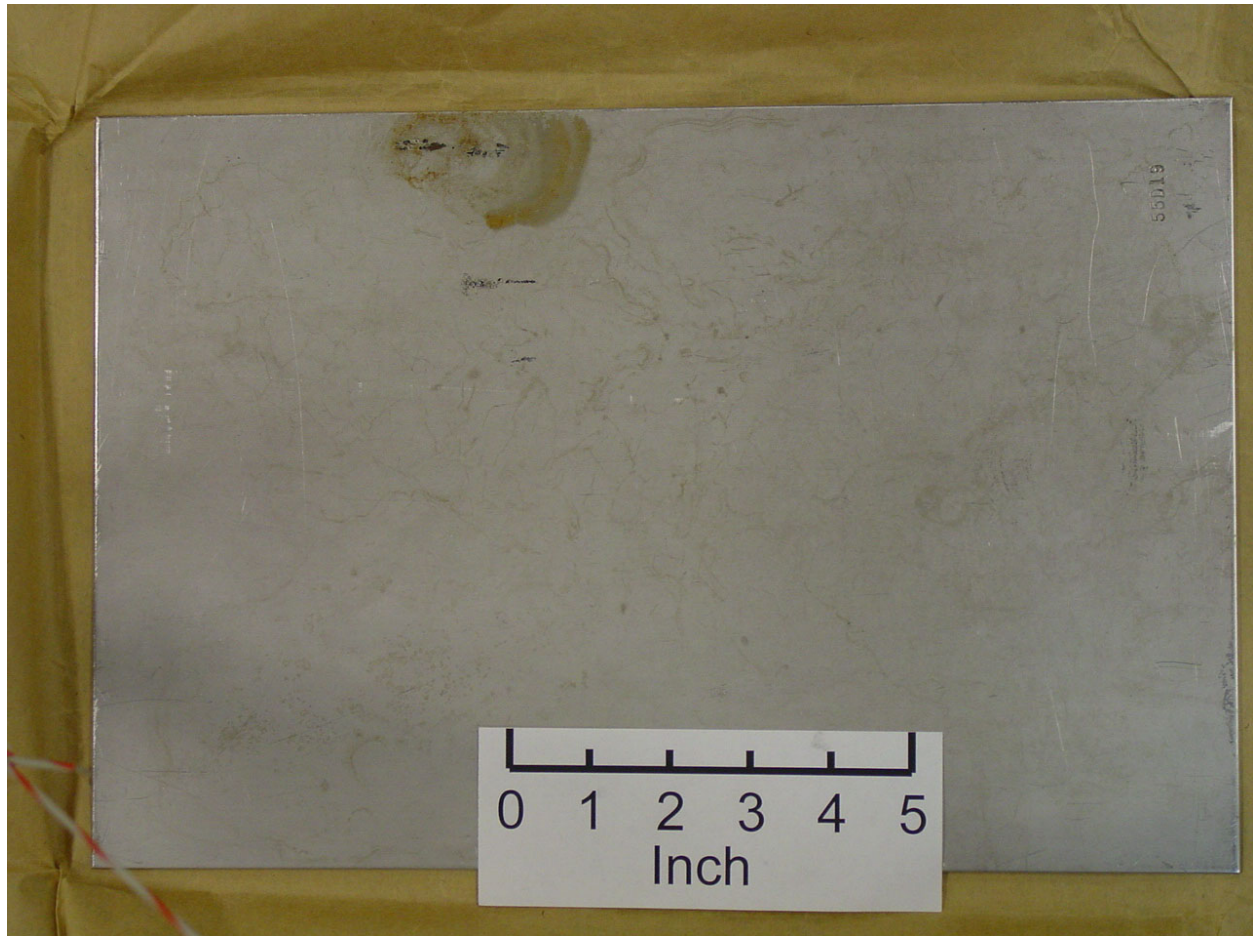
Figure 8. Solution annealed 304 stainless steel coupon after 34 years exposure underground.

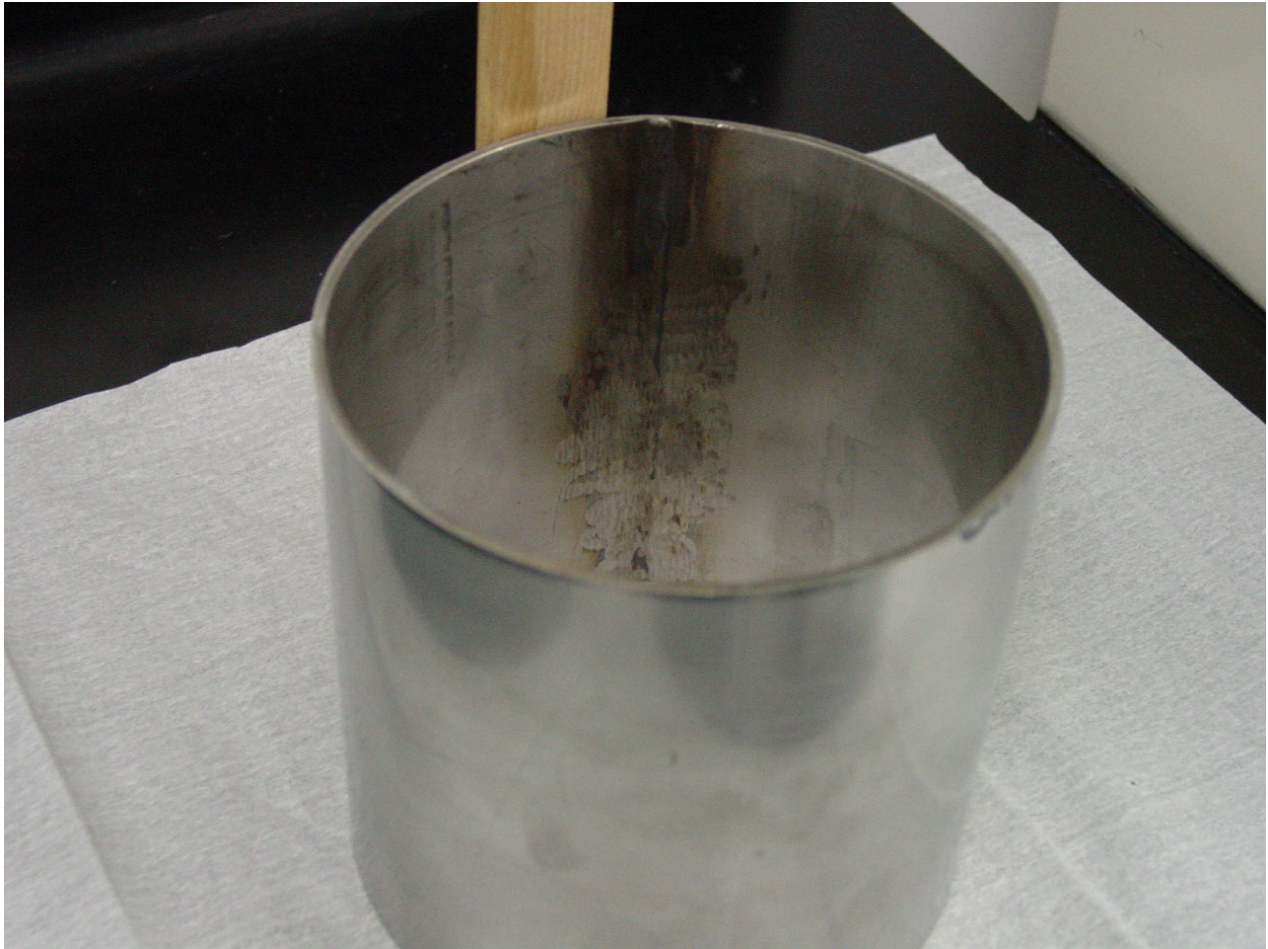
Figure 11. Welded 304 stainless steel coupon prior to exposure to chloride salts at 40 °C and 40% relative humidity

Figure 10 shows a finite element analysis model of a longitudinal weld for a 304 stainless steel vessel. For these tests the wall thickness was only 0.125 in. thick and the diameter was six inches. The model indicated significant tensile stresses (35 to 45 ksi) in the welds and the heat-affected zone. The areas of red and orange in Figure 10 are the areas of significant tensile stresses. Similar stresses would have occurred when the V-tanks were fabricated. A chloride salt was placed on the outside surface of these stainless steel coupons and kept at 104°F (40 °C) and 40% relative humidity. Figure 11 shows the stainless steel coupon prior to exposure to the chloride salts. Chlorides are known to cause stress cracking and pitting of type 304 stainless steel. Cracks were visible to the naked eye when the coupon was inspected after four months (Figure 12). The cracks were in the heat-affected zone.
